**HISTORIC PRESERVATION REVIEW BOARD  
STAFF REPORT AND RECOMMENDATION**

Landmark/District:	<b>Capitol Hill Historic District</b>	<input checked="" type="checkbox"/> Agenda
Address:	<b>19 Rear 4<sup>th</sup> Street NE</b>	<input type="checkbox"/> Consent
ANC:	<b>6C</b>	<input checked="" type="checkbox"/> Concept
		<input type="checkbox"/> Alteration
Meeting Date:	<b>December 19, 2019</b>	<input checked="" type="checkbox"/> New Construction
Case Number:	<b>20-096</b>	<input checked="" type="checkbox"/> Demolition
		<input type="checkbox"/> Subdivision

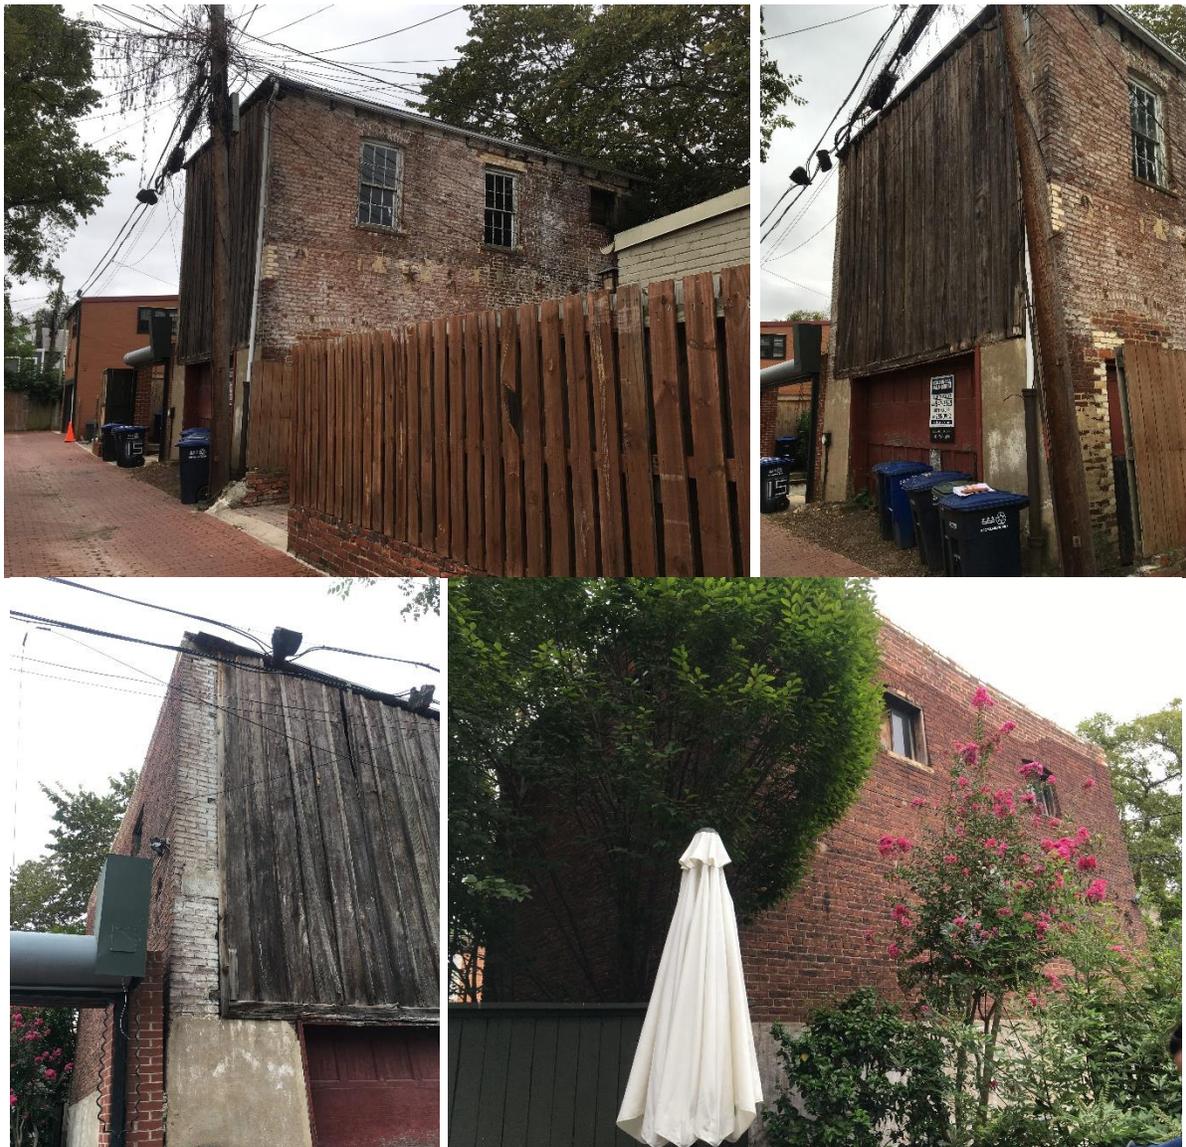
The building has been altered over time. Most significantly, the majority of the brick wall on the west (alley) elevation has been removed and infilled with a single retractable garage door on the first story and clad with wood boards on the second story. The north elevation, which used to have either a roof or lean-to addition, has a pedestrian door and three windows on the first story and another three windows on the second story. At the west (rear) elevation, the wall is mostly blank and has one window on the second story. The south elevation has been parged on the first story but shows signs of horse stall windows that have been infilled. The second story has two windows. At the interior and exterior of the building there are signs of various windows being altered or infilled on the north and south elevations. It appears the building's windows would have originally had segmental arches of two header rows.

*Photographs of the north, east, and south elevations of the existing two-story carriage house*

However, in HPO's touring the building with the applicant's structural engineer, its deterioration and precarious condition are clearly evident. The west wall is almost entirely missing, and the north and south walls are visibly racking and out of plumb. Sections of the top of the south and west walls appear to have been repointed or rebuilt, and the shallow foundations can be seen exposed on the interior. While it might conceivably be possible to retain some portions of exterior walls, this would likely still require substantial reconstruction of at least two of the three remaining walls.

*The HPO recommends the Board find the project to demolish the existing building and construct a new two story building in the same envelope to be compatible with the Capitol Hill historic district, and delegate final approval to staff.*
